### A New Solution for an Old Problem

*An innovative use of anchor blocks and tiebacks may solve a landslide condition on a steep roadside slope in Tennessee.*

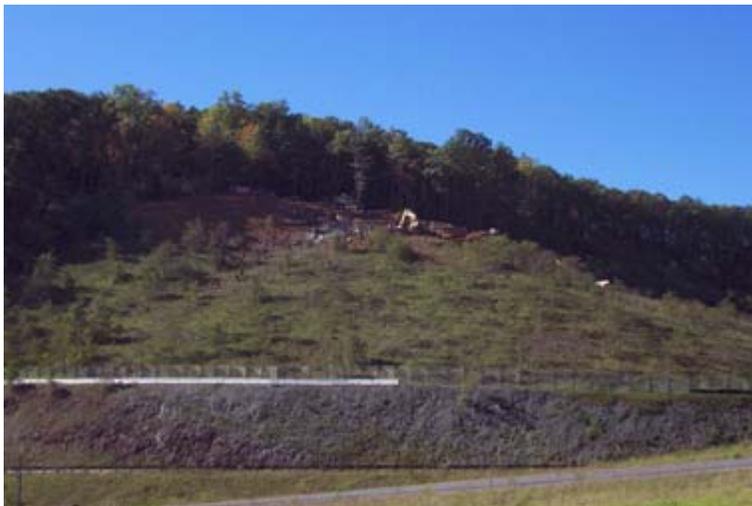
This view of the construction site from the interchange shows the concrete barriers and fence that were installed to prevent debris from entering the roadway below.

Movement of the slide at the intersection of the US 25E and US 58 cut slopes caused sandstone boulders to spill continually onto the US 25E eastbound roadway. EFLHD quickly protected against falling boulders by installing Jersey barriers along the roadway shoulder and partway up the slope along a bench.

Prior to the start of construction, EFLHD installed concrete Jersey barriers on the affected slope along US 25E. As an additional precaution, the contractor installed a high chain-link fence on top of the barriers. The fence prevented the numerous boulders that were dislodged during construction from overtopping the Jersey barriers and falling onto the road below.

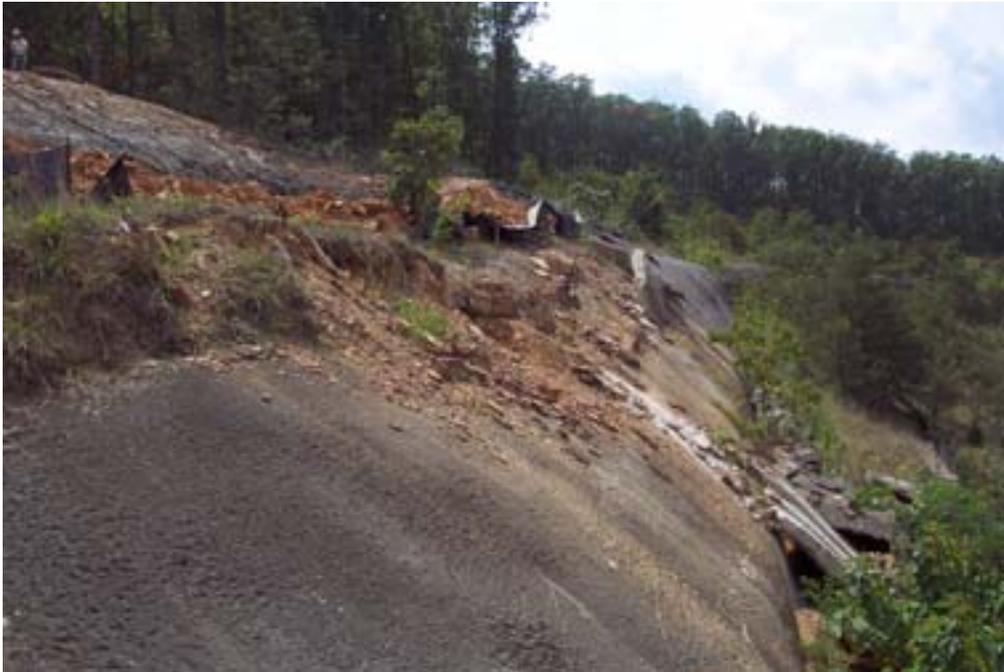
In addition, an earth ripple 0.9 meters (3 feet) high was prominent along the US 58 ramp and the US 25E toe of the slide at an elevation 479 meters (1,570 feet). The earth ripple also affected a nonstructural section of the soil nail wall by spalling off a large portion of shotcrete. Slope monitoring data revealed continuous slide movements accelerating during the spring, tapering off in the drier late summer and fall months.

This close-up shows the damage to the existing soil nail wall caused by the slide.

The second step was the actual bidding. The contractor that won the bid would perform the drilling for the tieback anchors and install them, place the shotcrete leveling pads for the anchor blocks, and repair the existing soil nail wall. Several subcontractors would construct the haul road, do the excavation and backfill, seat the anchor blocks, and place the topsoil after final grading.

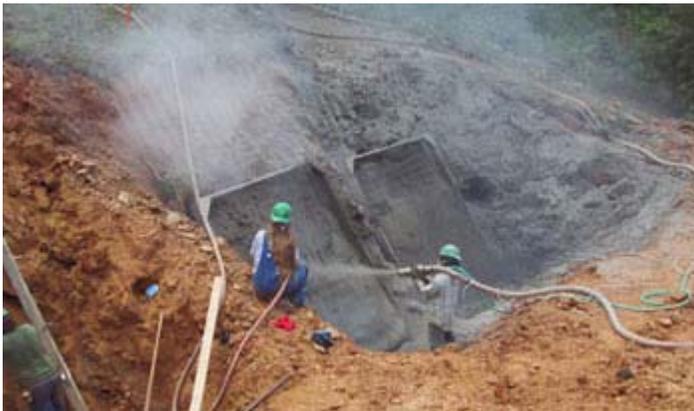
Workers are spraying shotcrete for one of the pads.

The engineers estimated that the anchor should develop load capacity when the tiebacks were drilled 9 meters (30 feet) into the Lower Rockwood. The intent also was to seat the blocks on a 152-millimeter (6-inch)-thick shotcrete leveling surface to minimize disturbance to the possibly uneven bearing surface.

Then the crew laid out a grid of 13 columns of anchor blocks in 10 rows on the slope. Using an excavator, the crew cut a bench into the slope and immediately placed the shotcrete leveling pads against the slope. After a shotcrete leveling

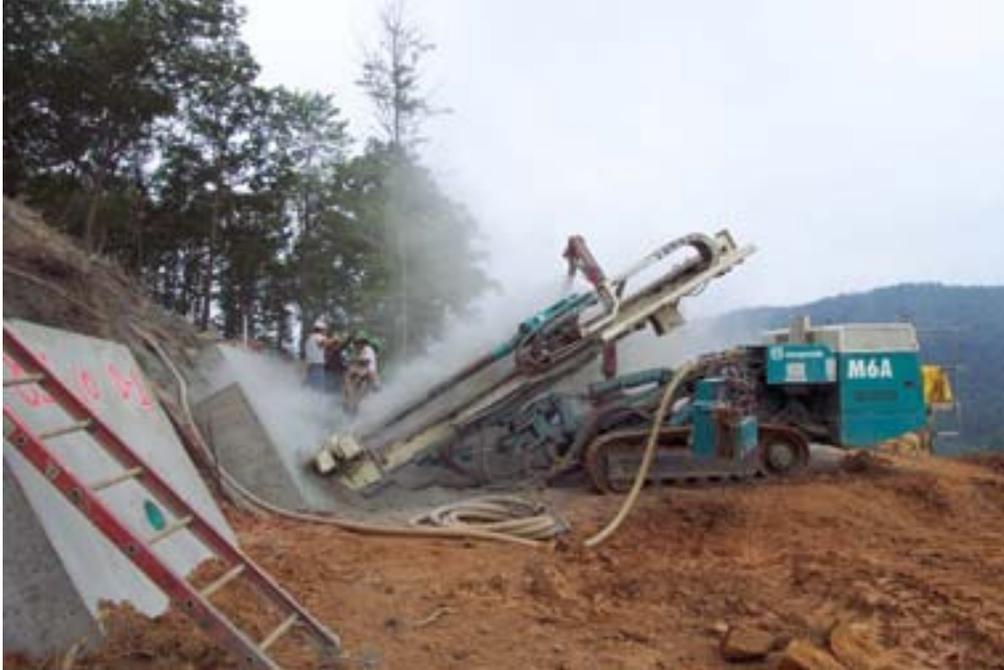
The contractor is drilling for the ground anchors. Note the anchor block set prior to drilling.

A compressed-air rig drilled holes for the tiebacks, which varied in length from 26 to 32 meters (85 to 105 feet). An excavator and boom fork lowered the tieback tendons into the holes, and the contractor then grouted the tendons and cast grout cubes. After the grout cubes reached the required strength (usually 3 days), the contractor stressed the tiebacks to 100 percent of design load. Typically, little to no movement of the anchor blocks was observed during stressing.

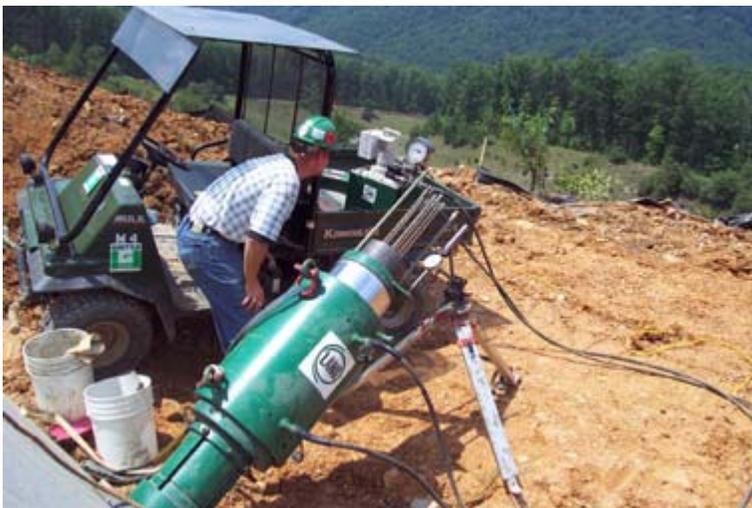
Proof loading an installed ground anchor.

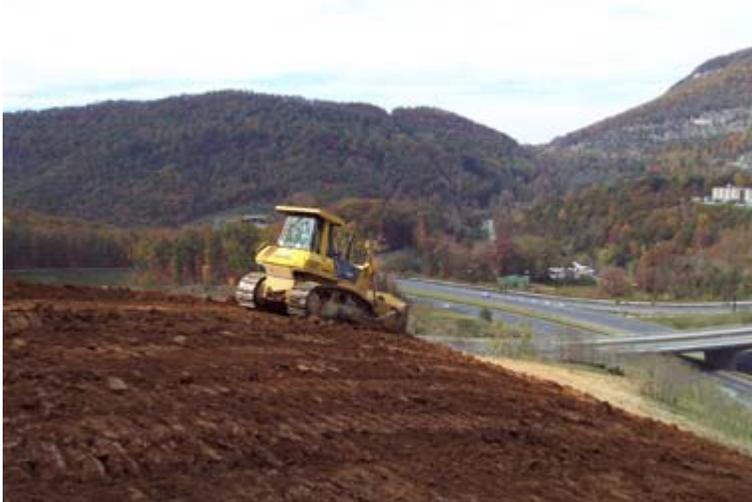
The contractor placed fill material over the anchors and is shown restoring the site to its original contours.

Due to the unusually dry summer, all the tiebacks were completed by early October 2001. An excavator and a bulldozer recontoured the slope and added topsoil prior to seeding. Three permanent piezometers and inclinometers were installed, and the access road was restored to the original contours—well ahead of schedule.
