A New Solution for an Old Problem

An innovative use of anchor blocks and tiebacks may solve a landslide condition on a steep roadside slope in Tennessee.

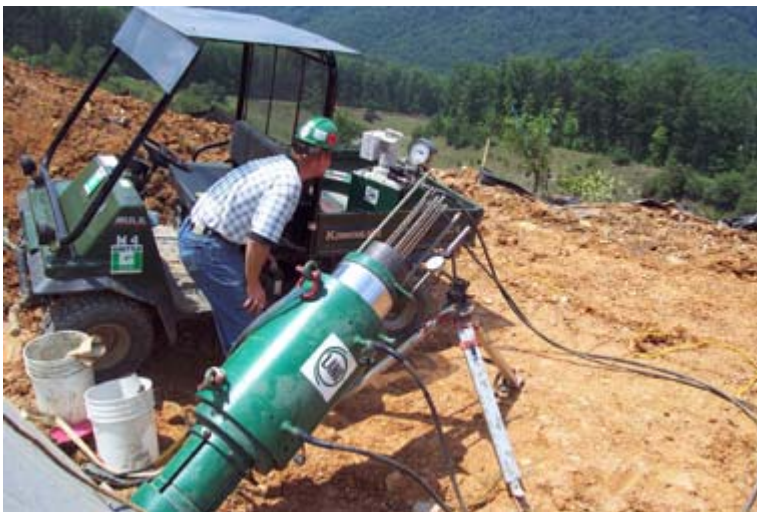
Proof loading an installed ground anchor.

A compressed-air rig drilled holes for the tiebacks, which varied in length from 26 to 32 meters (85 to 105 feet). An excavator and boom fork lowered the tieback tendons into the holes, and the contractor then grouted the tendons and cast grout cubes. After the grout cubes reached the required strength (usually 3 days), the contractor stressed the tiebacks to 100 percent of design load. Typically, little to no movement of the anchor blocks was observed during stressing.
